AFWAL-TR-84-2014

IMPROVEMENT OF THE CORROSION RESISTANCE OF TURBINE ENGINE BEARINGS

United Technologies Corporation
Pratt & Whitney Aircraft
Engineering Division
P.O. Box 2691, West Palm Beach, Florida 33402

Interim Report for Period August 1981 — July 1983

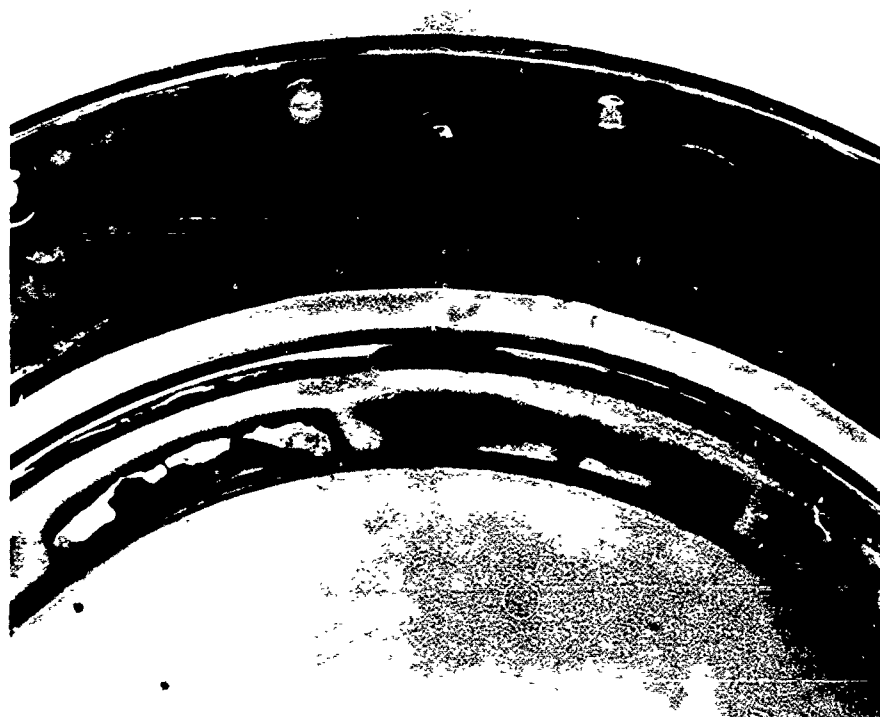
FD 230896

Figure 9. Thick-Thin Preservative Boundary Morphology As Seen Through Plastic Skin-Pack (Main Shaft Bearing N)

Corrosive attack of stored M50 steel races and rolling elements was several orders of magnitude less severe in appearance than that of the associated silver-plated cages. However, even the lightest corrosive attack of the functional surfaces of the M50 steel components was considered much more serious than the plated cages due to the potential catastrophic failure of these parts from progressive spalling initiated at such sites. Corrosive attack of the M50 steel components varied from widespread, extremely light stains, barely discernible to the eye (and invisible to standard macrocameras, SEM and XES), to very heavy, black or brown stains and pitting. The lightest stains generally conformed to the thick-thin preservative boundary morphology, and heavier stains to the race-rolling element contact morphology as shown in Figures 9 and 10.

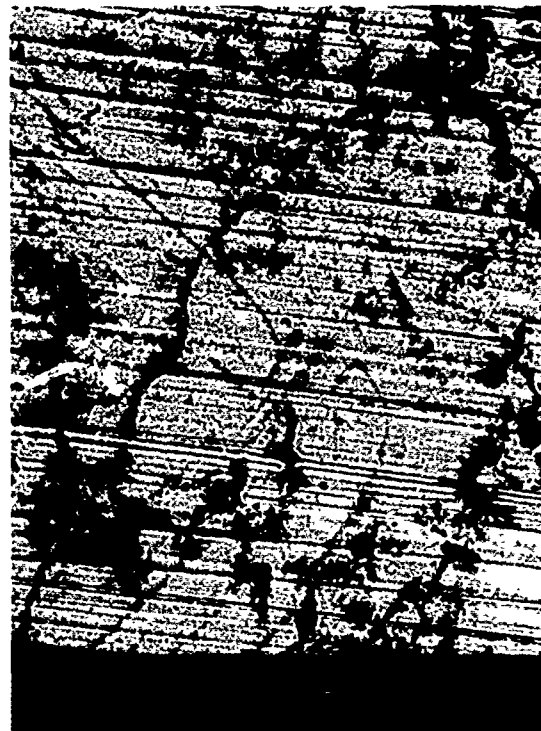
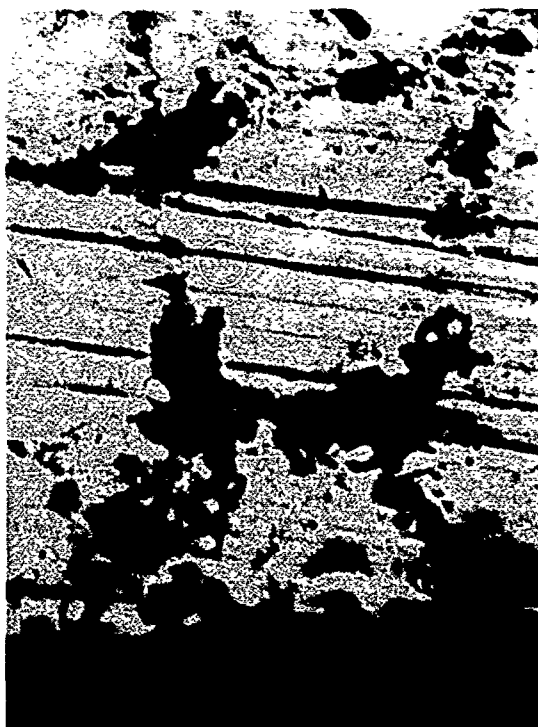
Mag 500X

Mag 2000X

Figure 15. SEM Photomicrographs and XES Spectra of Lightly Stained M50 Bearing Material (Main Shaft Bearing C) Which Appears to Follow the Grain Boundary Morphology (Arrows)

Corrosion corresponding to slightly darker stains of the M50 material (mainshaft bearing C) which was amenable to SEM, XES analyses, appeared to follow the grain boundary morphology (Figure 15). Localized stress concentration in the lattice structure along the grain boundary, i.e., grain boundary energy, rather than transgranular differences of chemistry, is believed to be a primary mechanism responsible for initiating autocatalytic pitting corrosion along grain boundaries in the storage environment.

The *mudcracking* effect may represent the final stages of autocatalytic pitting corrosion initiated along grain boundaries (compare 200 \times photos in Figures 15 and 16) and producing a trench-shaped crevice (crack) which ultimately spalls, exposing fresh surface to further attack. This type of corrosion of functional bearing surfaces, if undetected, can result in failure.

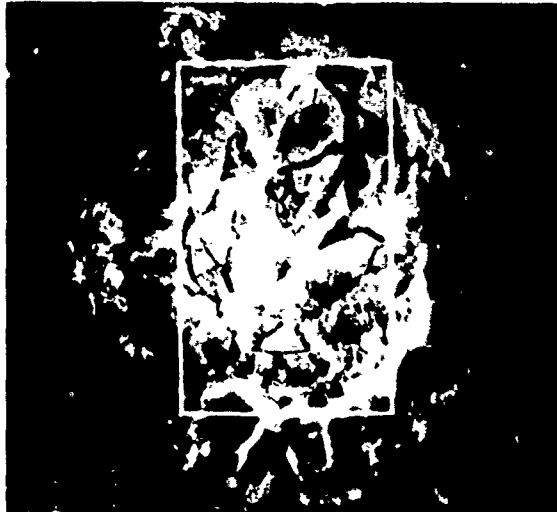
XES Spectra in "Mudcracked" Region, Area B

Mag 900X

Figure 16 SEM Photomicrographs and XES Spectra of Dark Black Stains on M50 Steel Roller Showing Apparent Enrichment of Alloying Elements (Cr, Mo, V) Relative to Iron in Location of Corrosive Attack

The most severe corrosive attack of M50 components in storage was manifested by dark black stains usually conforming to rolling element-race contact morphologies (Figure 10). SEM photomicrographs of these stains revealed severe *mudcracking* and spalling of the *mudcracked* corrosion product. XES analysis of these *mudcracked* regions typically revealed enrichment of the alloying elements (Cr, Mo, and V) relative to iron except in locations of spalling in which fresh unaffected surface was exposed (Figure 16). This is probably due to the leaching out of the more soluble iron corrosion products or, similarly, precipitation of less soluble alloying element corrosion products due to the decreasing concentration gradient of the attacking media from the bottom of a local pit to the surface of the alloy.

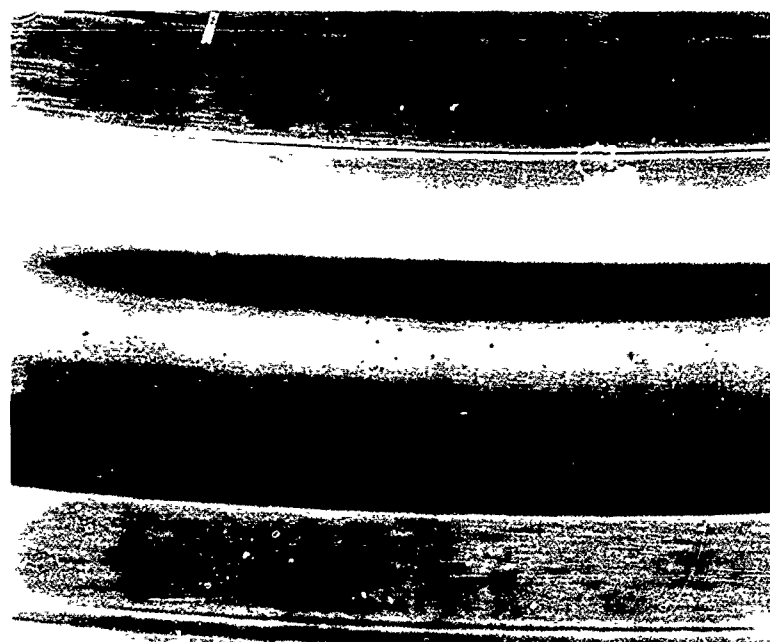
FD 230890

Mag 3 3/4X

Pitting Attack of Outer Race

Figure 18. Pitting Attack of Functional Surfaces of Service-Rejected Bearing (Main Shaft Bearing J, Service in MIL-L-7808 Oil)

Corrosive attack of M50 and BOWER 315 steel rolling elements and races of service bearings was less evident than that of stored bearings (Figure 17). Staining of the alloy surface was not encountered. Rather, the morphology of the corrosive attack of these bearing components was confined to almost microscopic pitting which, though widespread, was difficult to see except at higher magnification (Figures 18 and 19).

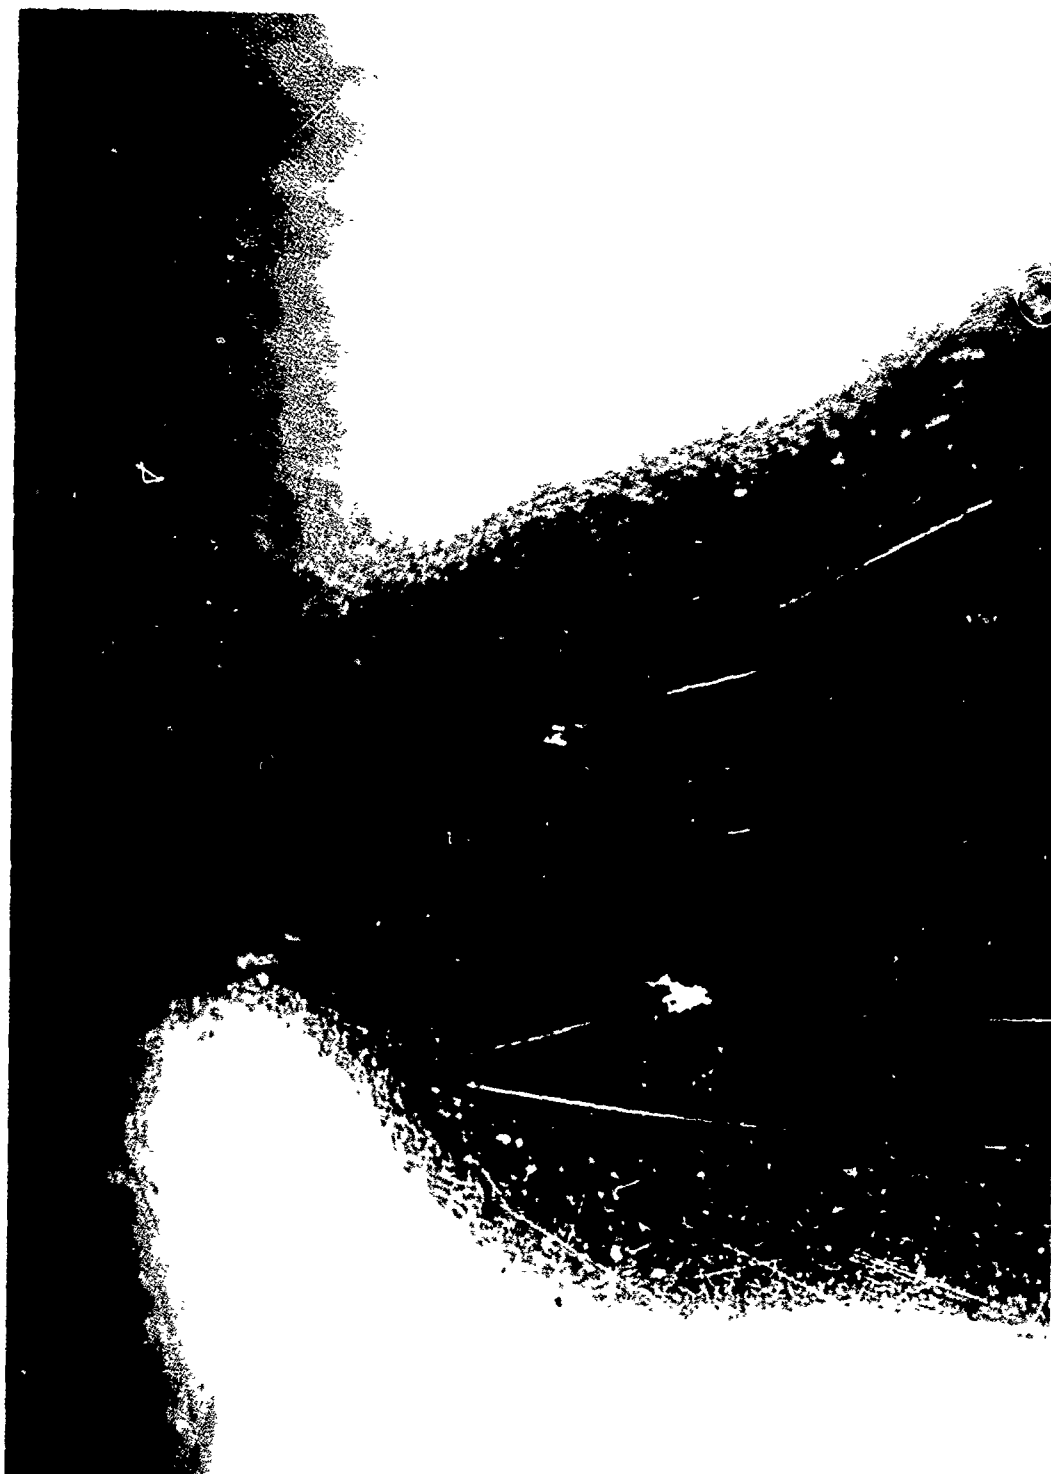
FE 352766

Figure 19. Pitting Attack of Ball in Figure 18 (Mainshaft Bearing J, Service in MIL-L-7808J Oil)

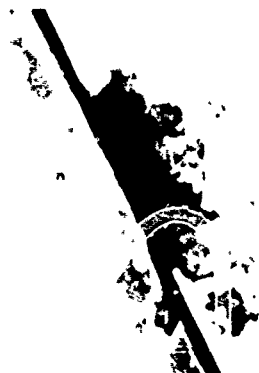
Mag 3000X

Embedded Particle in Functional Surface
of Rolling Element

Mag 1500X

Site of Probable Autocatalytic Pitting Attack

Figure 21. SEM Photomicrographs and XES Spectra of Locations of Embedded Particles and Probable Autocatalytic Pitting Attack Initiated at Those Locations (Main Shaft Bearing K)

Corrosion-like morphologies were found in the regions of some indentations (Figure 20). In the absence of static exposure to a relatively corrosive environment (storage with MIL-C-11796B), it is postulated that corrosive attack is more readily initiated at locations of physical damage rather than at grain boundaries. Small particles embedded in functional surfaces provide relatively large areas of closely conforming surfaces which are very amenable to capillary adsorption of water in the system (and attendant reactive species). Thus, an area of physical damage is easily converted to a site for autocatalytic pitting attack as seen in Figures 21 and 22.

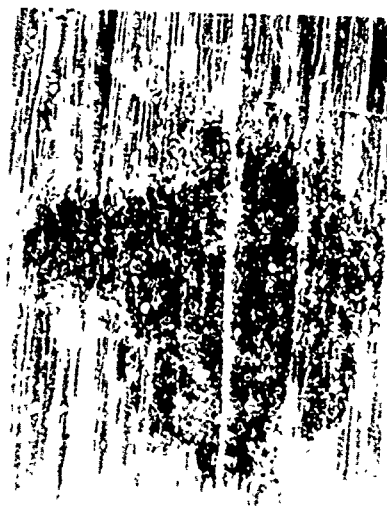
Mag 300X

Pitting Attack of Functional
Surface of Roller

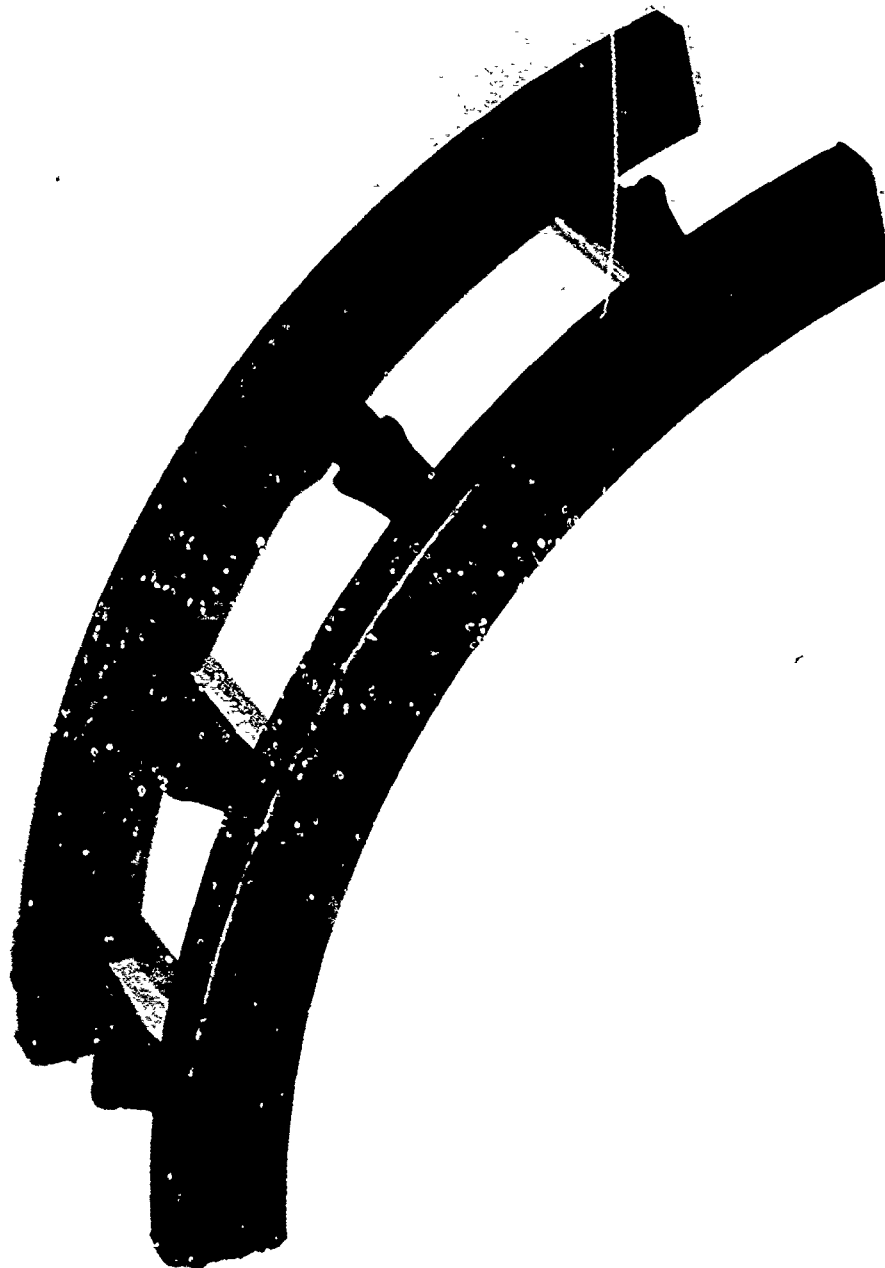
FE 352756

Figure 23. Section of Cage Examined Via SEM, XES and MET Analyses for Thin Dark Stains (Accessory Bearing H)

For the most part, corrosion of the silver-plated AISI 4340 steel resembled that of bearings subjected to a storage environment. The cage of one accessory bearing exhibited a feature not previously encountered with silver plating, i.e., *mudcracking*. Examination of thin, dark stains of the cage (Figure 23), via SEM and XES analyses, revealed heavy *mudcracking* and pitting (spalling) similar to that seen on M50 steel components subjected to a severe storage environment (Figure 24). *Mudcracking* of the silver plate is not serious in terms of precipitating a failure of the cage, but spalls can cause indenting of functional surfaces (Figure 25), and may progress to flaking of the silver plate.

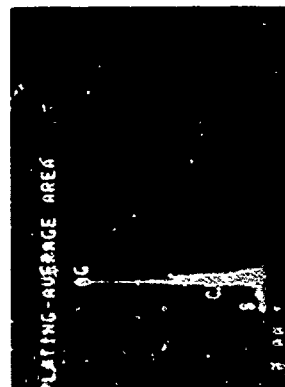
XES Spectra of Unstained Region

Figure 24. SEM Photomicrographs and XES Spectra of Thin, Dark Stains of Silver-Plated AISI 4340 Steel Showing "Mudcracked" Morphology and High Sulfur Content in Locations of Corrosive Attack (Accessory Bearing H)

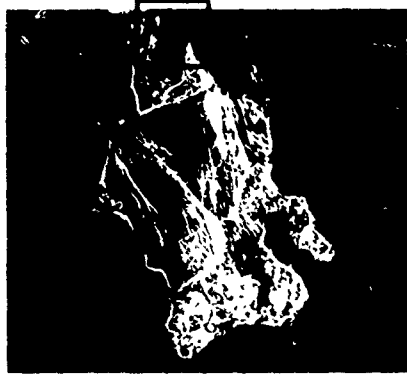
Mag 1000X
"Mudcracked" Region Showing Location of
Spalls of Silver/Silver Sulfide

Mag 3000X
Pit Formed as a Result of Spalling
of Silver/Silver Sulfide

Example of Silver Particle Lodged in
Extreme Right of Indentation or Incipient
Spall of Functional Surface of Outer Race

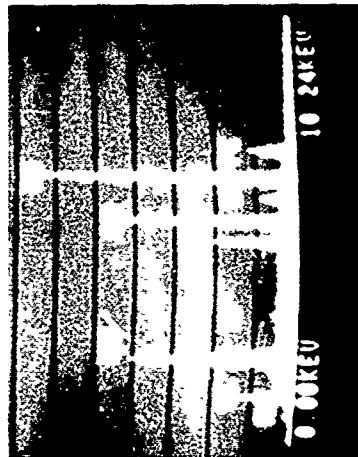
Mag 800X Mudcracked Region

Molybdenum X-ray Map

XES Spectra of Mudcracked Region
Compare Spectra of M50 Base Material
Figure 26

Aluminum X-ray Map Showing Large
Number of Embedded Particles

Figure 27. SEM Photomicrographs, XES Spectra, and X-ray Maps of "Mudcracked" Region of Figure 26 Showing Relative Enrichment of Alloying Elements Due to Leaching Away of Iron Corrosion Products

SEM and XES analyses of M50 steel components revealed characteristics of both storage and service environments. They exhibited the *mudcracking* and spalling corrosion typical of storage, as well as, the indenting, scratches, wear, and embedding of silicon and aluminum (oxide) particles representative of parts exposed to service (Figures 26 and 27).

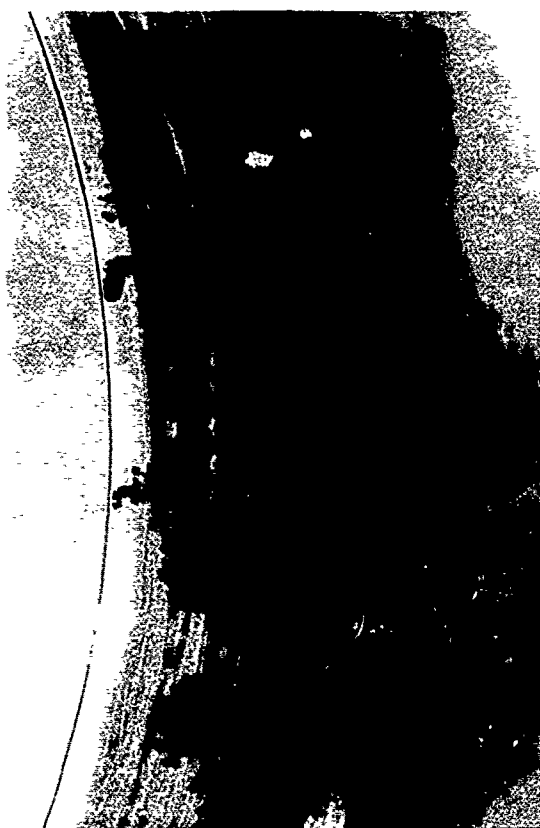
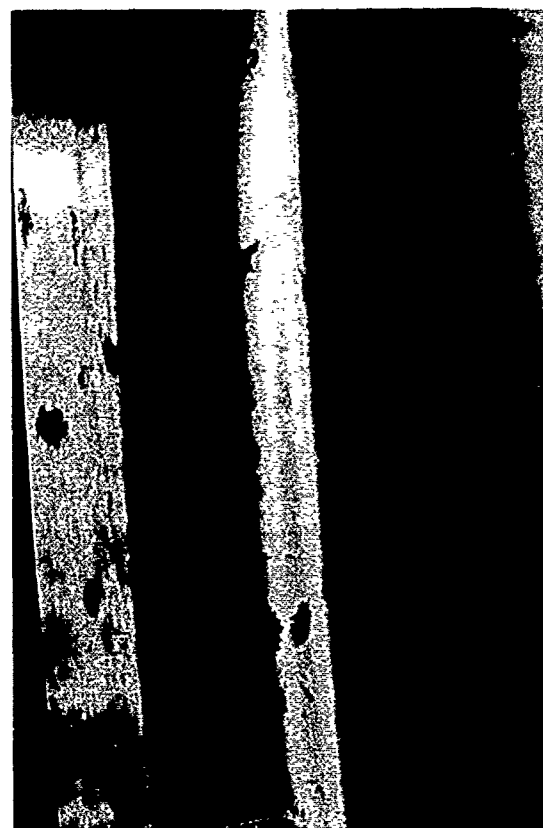
Mag 1 1/2X
Typical Appearance of Corrosion
of Non-Functional Surfaces

Mag 1 3/4X
Pitting Corrosion at Preservative-Atmosphere
Phase Boundary on Outer Race Surface

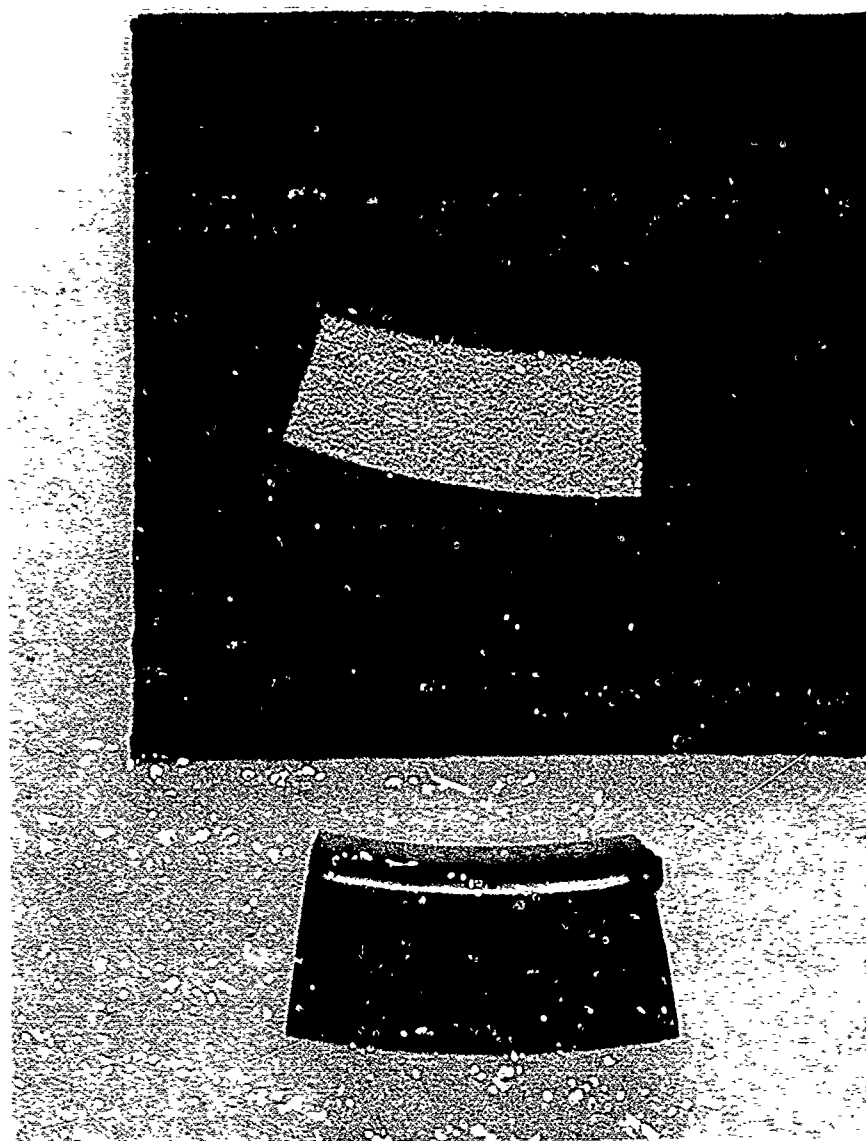
FE 352751

Figure 35. Specimens (M50 Steel at Bottom; Silver-Plated Coupon at Top) Exposed to 0.0020 Wt% Sulfur (as Triethylthiol) in Mineral Oil at 140°F for 24 Hours

M50 steel and silver plated pairs were also tested by immersion in dry mineral oil solutions containing tritylthiol (triphenylmethyl mercaptan) at 0.0100 W %, 0.0020 W % and 0.005 W % sulfur concentrations and solutions containing trityl chloride (chlorotriphenylmethane, triphenylmethyl chloride) at the same levels of chloride concentration. Samples were again placed in an oven at 140°F for 24 hours. Results indicated that the silver plate was the most susceptible material to attack by both chloride ions and reactive sulfur down to the lowest concentrations tested, sulfur producing the heaviest stains. M50 steel was unaffected by the reactive sulfur and all but the highest concentrations of chloride ions (Figures 34 through 39).

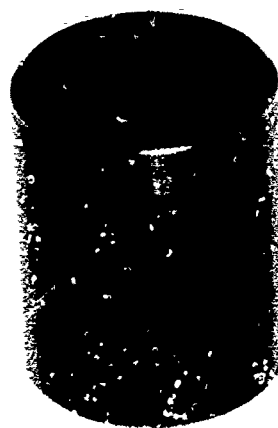
FE 352740

Figure 36. Specimens (M50 Steel at Bottom; Silver-Plated Coupon at Top) Exposed to 0.0100 Wt% Sulfur (as Trityl Thiol) in Mineral Oil at 140°F for 24 Hours

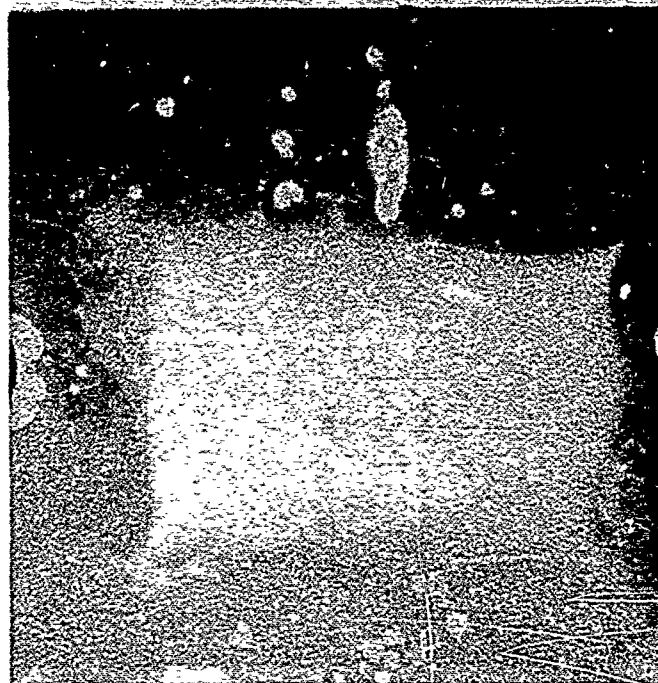
FE 352725

Figure 38. Specimens (M50 Steel at Bottom; Silver-Plated Coupon at Top) Exposed to 0.0020 Wt% Chloride (as Trityl Chloride) in Mineral Oil at 140°F for 24 Hours

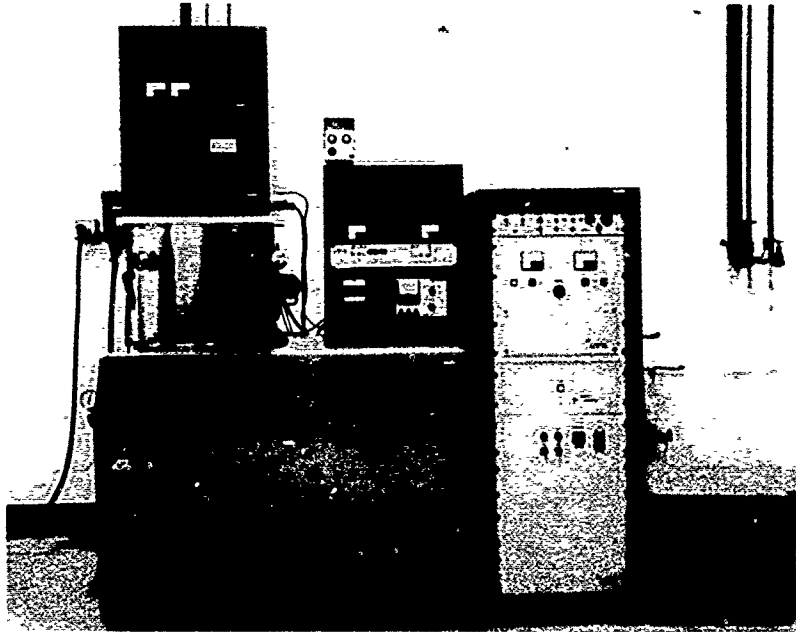
FD 270314

Figure 45. Planar Target Radio Frequency (RF) Diode Sputtering System

The RF sputtering system is shown in Figure 45 and the coating chamber was previously illustrated in Figure 40.

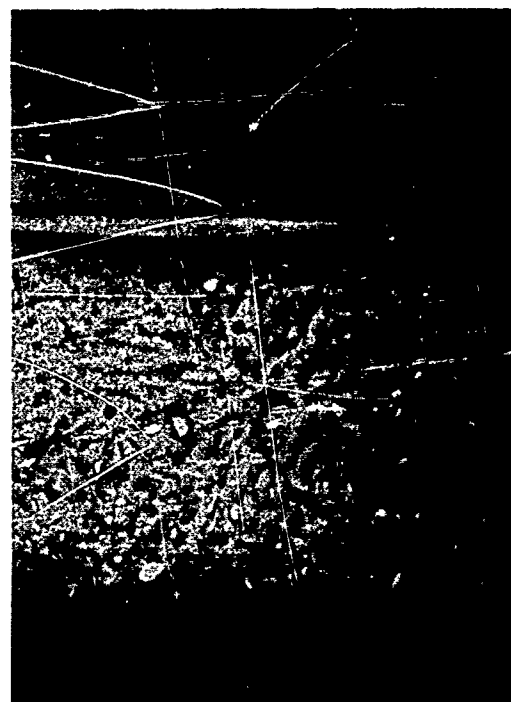
The thickness of the sputtered deposit was determined from a scanning electron microscope photomicrographs of polished cross sections of coated trial specimens. Measurements taken from these photos showed that a two-hour deposition cycle would yield a coating approximately 0.000045 (11,300 angstroms) thick as illustrated in Figure 46.

Nickel Plate Applied for Edge
Retention of Sputtered Coating
During Polishing

Sputtered Nickel

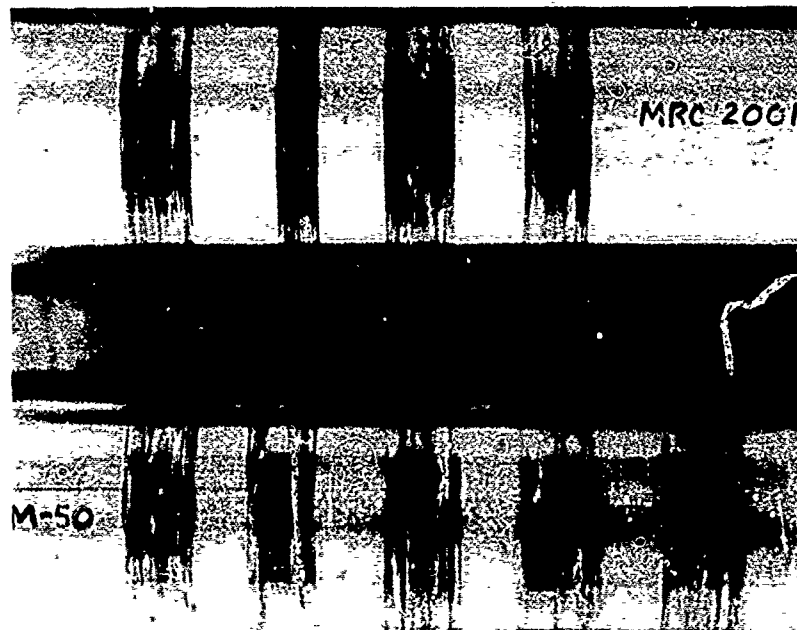
Figure 90. Rotating Wear Test Bars Showing Representative Tracks on M50 and MRC2001 Specimens (Scale Magnification Approximately 3×)

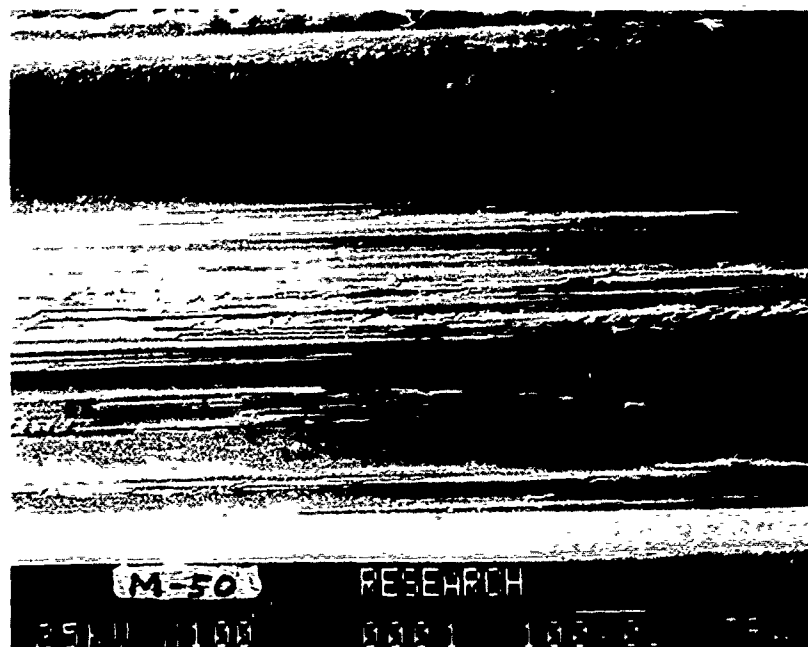
Figure 92. SEM Photograph of the Bottom of a Typical Wear Scar on an M50 Stationary Bar. Magnification: 100×
